JOURNAL OF THE INSTITUTE OF HEALTHCARE ENGINEERING AND ESTATE MANAGEMENT

# Tap upgrade wins praise all round

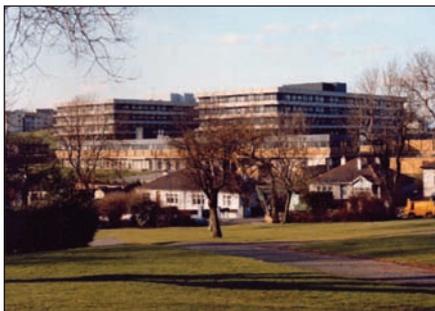
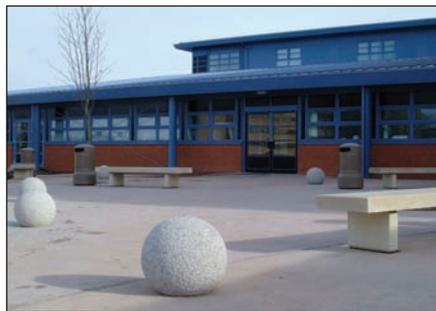
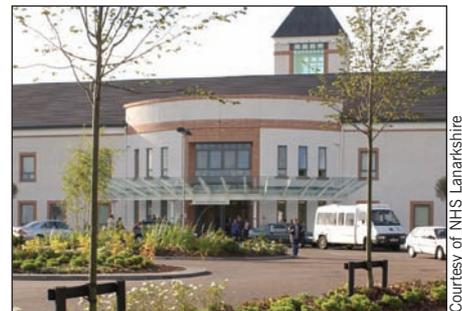
*Optitherm taps are now in use, or being installed, not only at the Monklands Hospital (left), but also at the Hairmyres Hospital (centre) in East Kilbride, and at the Wishaw General Hospital (right).*

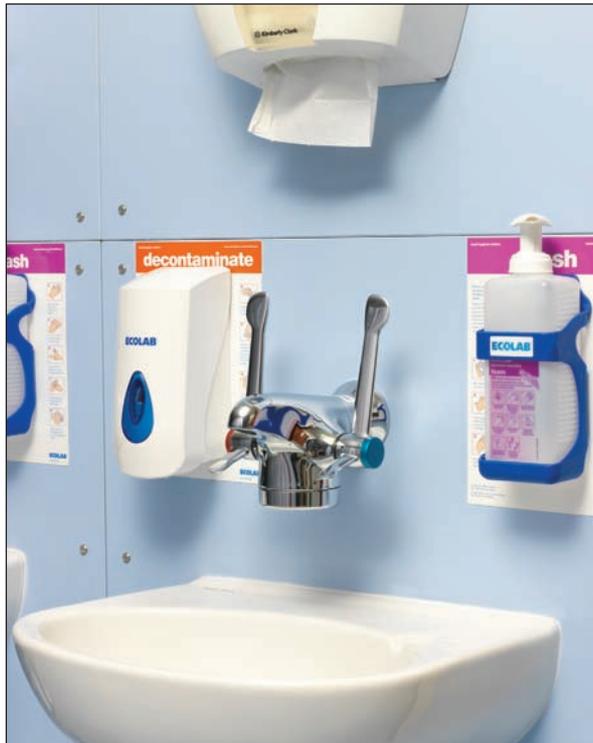
*The Optitherm was considered very easy to clean due to its smooth and rounded shape, and “lack of nooks and crannies”, while access for maintenance is also straightforward, with no need to remove the wall panel.*

From a cleaning and infection prevention perspective, the tap was considered very easy to clean due to its smooth and rounded shape, and "lack of nooks and crannies". The infection control team was initially concerned about the combined flow regulator and conditioner, and there was much debate as to whether it was an aerator or not. Once its function was properly explained – it regulates the flow to 6 litres/minute, and "conditions" the water column to ensure it falls in a uniform, unbroken manner into the basin with no splashing or forming of aerosols – this was accepted, and the Optitherm was selected for installation.

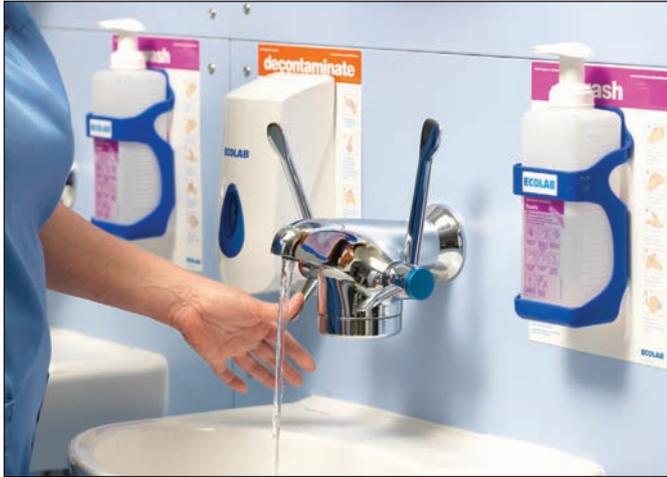
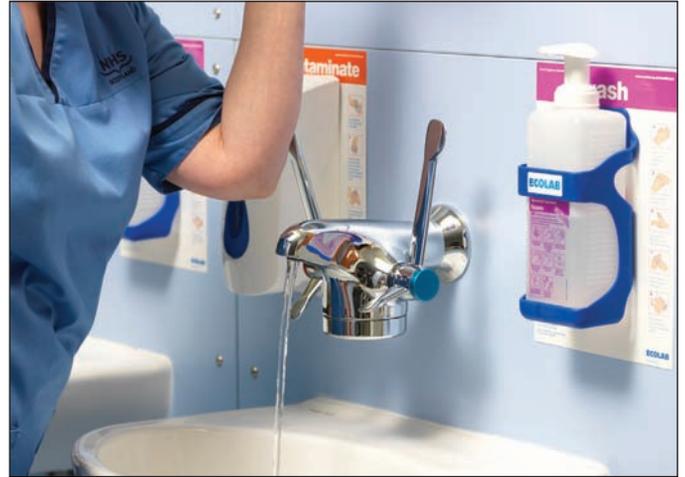
To aid hygienic handwash, the Optitherm's double lever operation allows the tap to be operated using the thumb, then turned off using the elbow or upper forearm, while the outer surface is continuous and smooth for easy cleaning.

The anti-vandal clutch mechanism on the levers was also considered a valuable feature, as it prevents the levers from snapping should excess force be applied to them. A person intent on breaking the lever may push it in either direction with force; initial resistance will suddenly cease as the lever moves around its axis by a “notch”. The vandal incorrectly assumes that the

lever mechanism is broken, but this is a deliberate feature, and there is no risk of the lever snapping. The lever position is corrected simply by ratcheting it back in the reverse direction, again with moderate force, until the resistance ceases.
