## SP-200A Push Button Cleaning Procedure

Waterborne debris can result in the SP-200A not fully shutting off. This procedure addresses this issue.

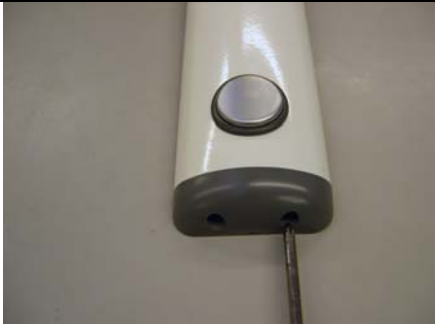
1. Isolate the water supply. Remove the two screws securing the lower cover (small cross-head screws).

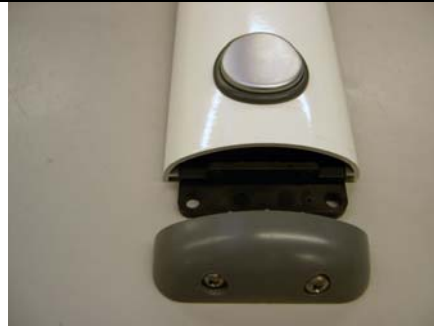
2. Remove the lower cover

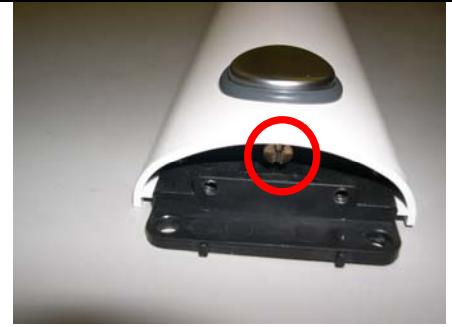
3. Locate the push-button retaining screw (brass with straight screwdriver slot).

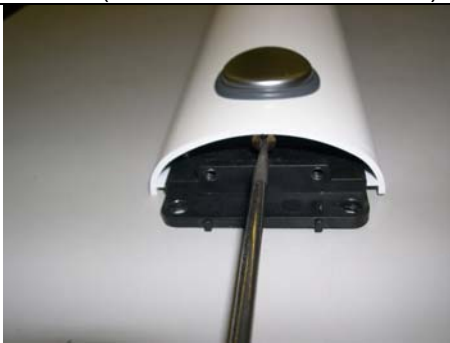
4. Unscrew the pushbutton retaining screw using a flat bladed screwdriver...

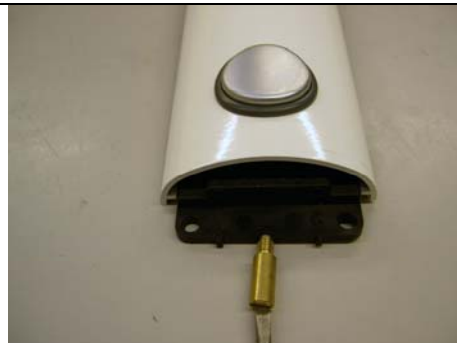
5. ...and remove it.

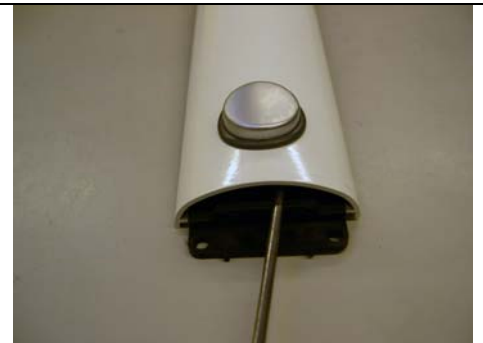
6. The pushbutton can now be removed. Gently prise it out from behind.

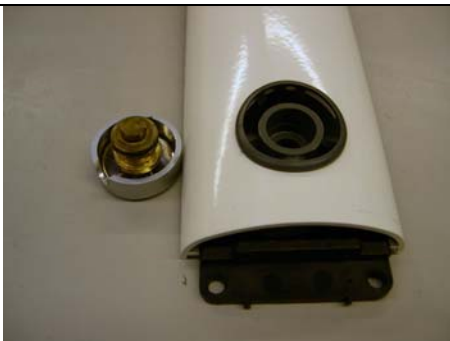
7. Remove the pushbutton, taking care not to damage the seal on the pushbutton or the bore of the cylinder.

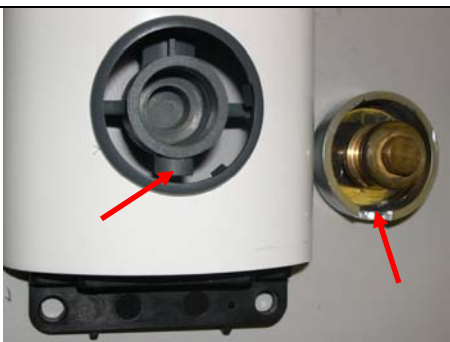
10. Reassembly is a simple reversal of the procedure. Note that the cut-out in the pushbutton must line up with the housing.

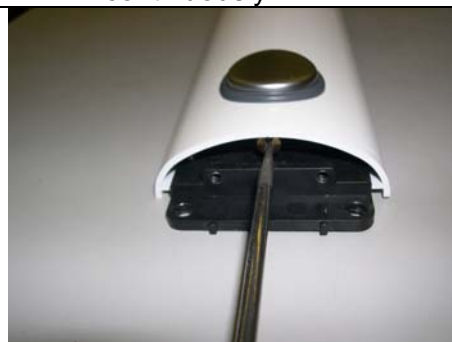
11. Note also that Blu-Tak or similar substance can be used to attach the push-button retaining screw to the screwdriver. Hold the pushbutton in during this.
